# UNDERWATER BRIDGE INSPECTION REPORT

STRUCTURE NO. 27510

ARCOLA CHANNEL

MINNESOTA DEPARTMENT OF TRANSPORTATION  
UNDERWATER BRIDGE INSPECTION

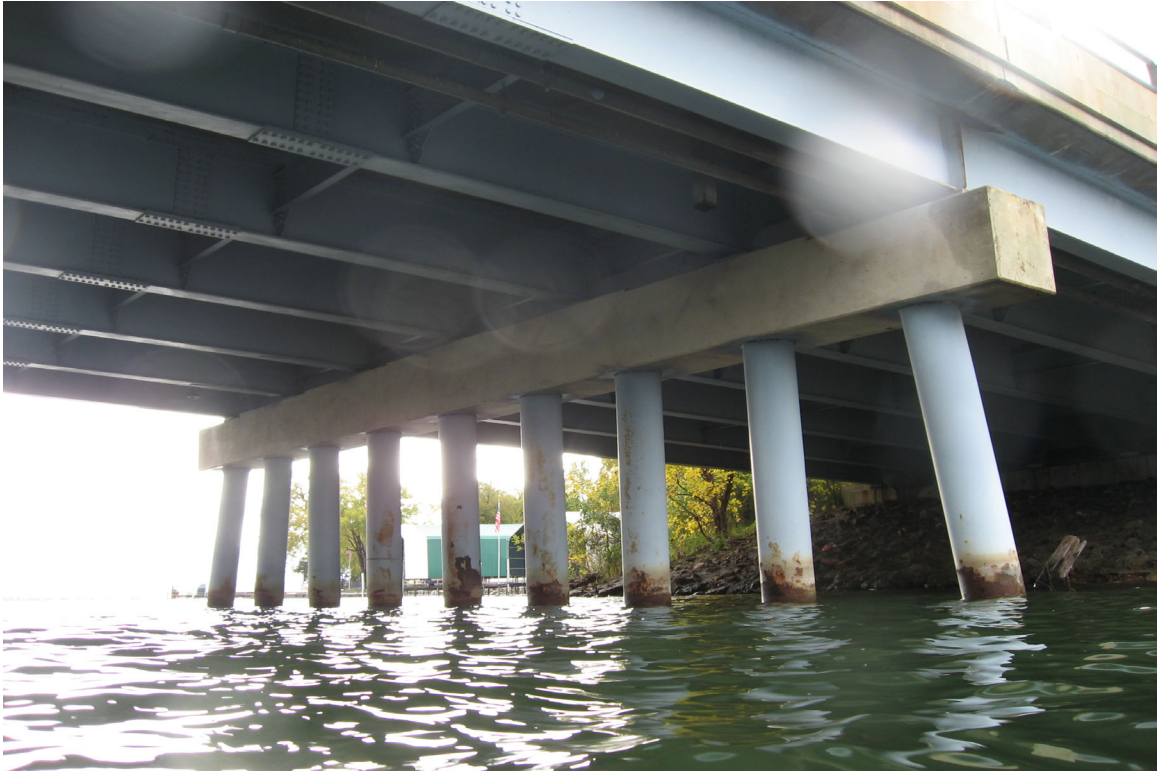
Photograph 1. View of Pier 1, Looking South.

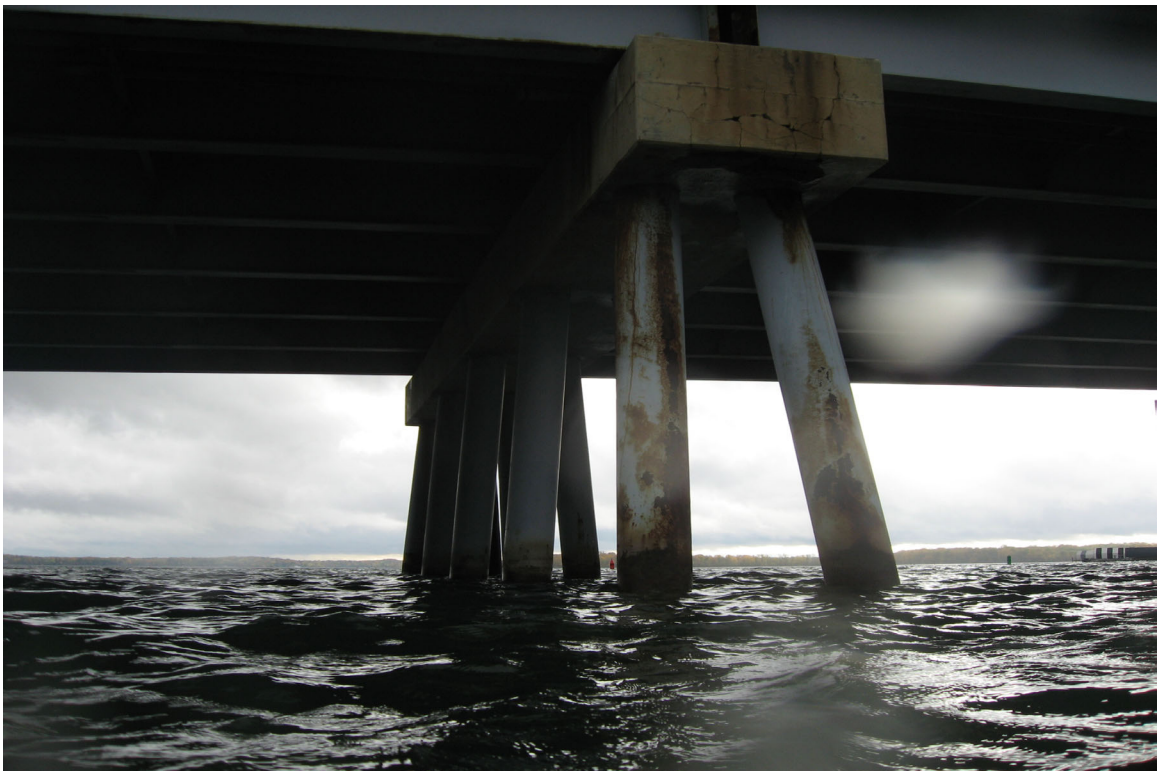
- (D) Minor cracking was observed at the northwest end and heavy cracking at the southeast end of the Pier 6 and Pier 2 pier caps. In addition, the pier cap ends in general exhibited random cracking.

Photograph 2. View of Pier 2, Looking South.

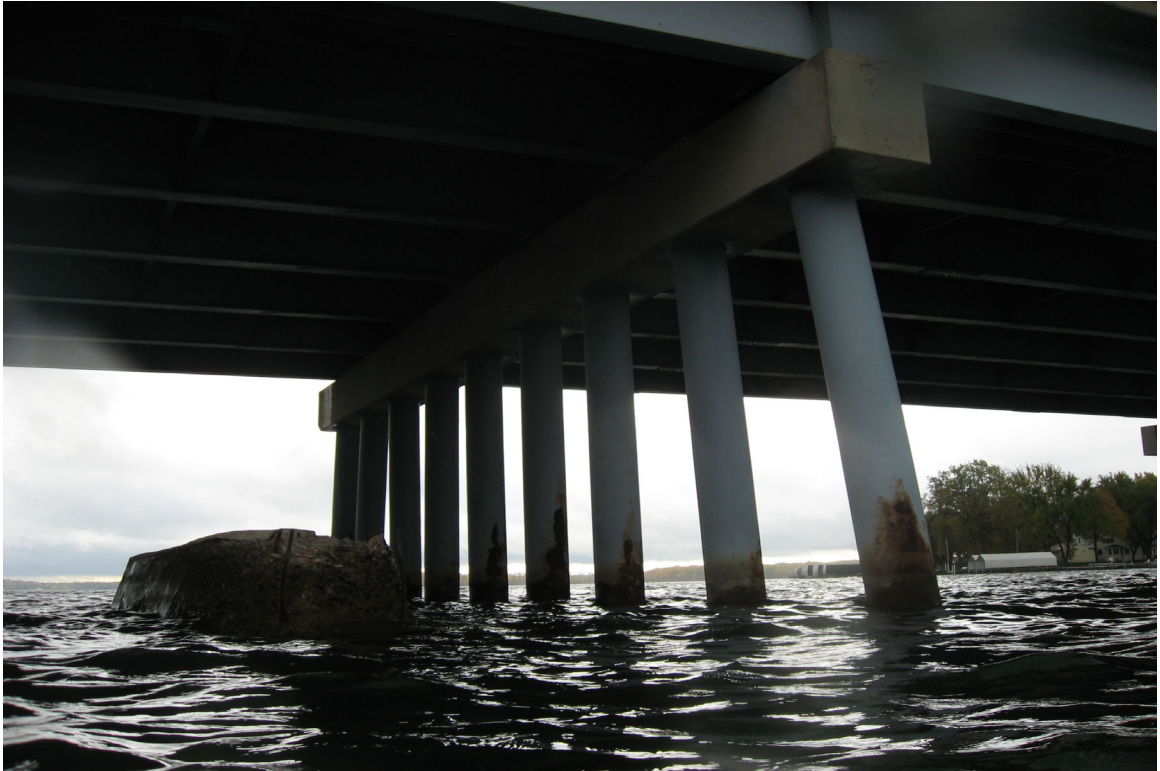
Photograph 3. View of Pier 3, Looking South.

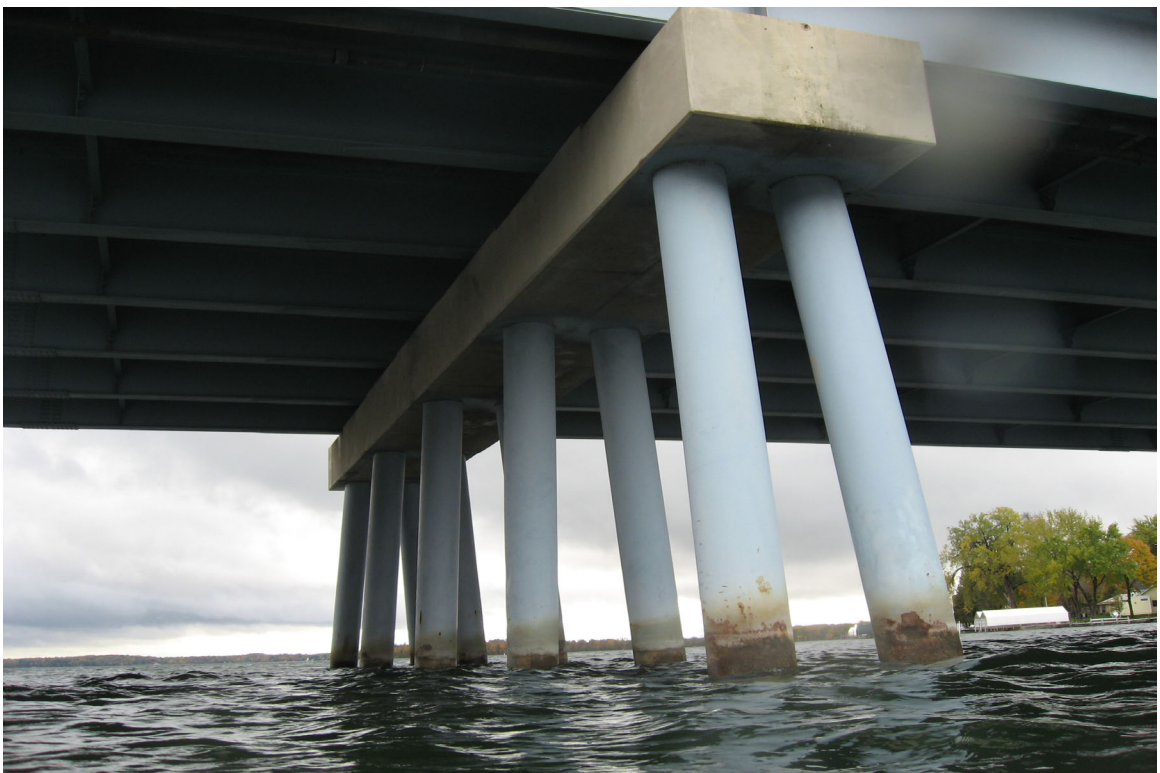
Photograph 4. View of Pier 4, Looking South.

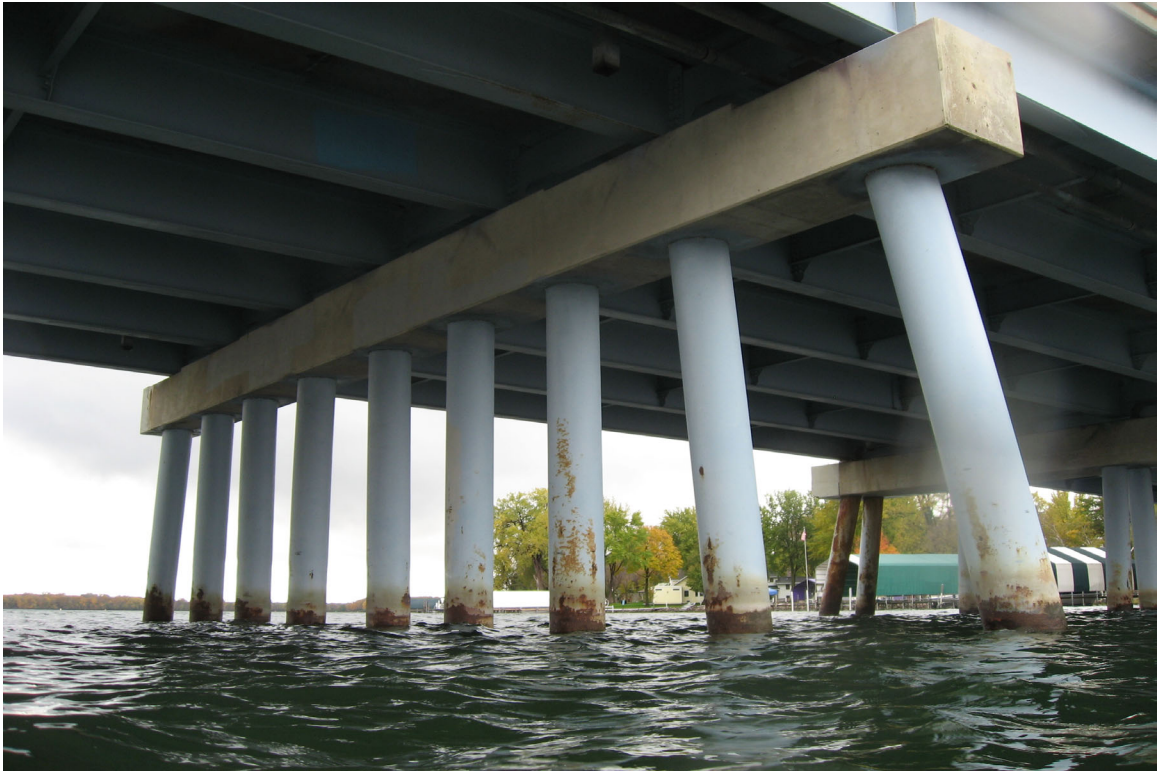
- (F) The pier cap at Pier 5 has exposed reinforcing steel at the southeast end on the south side of Pier 5. Section loss similar to that described at Pier 7.

Photograph 5. View of Pier 5, Looking South.

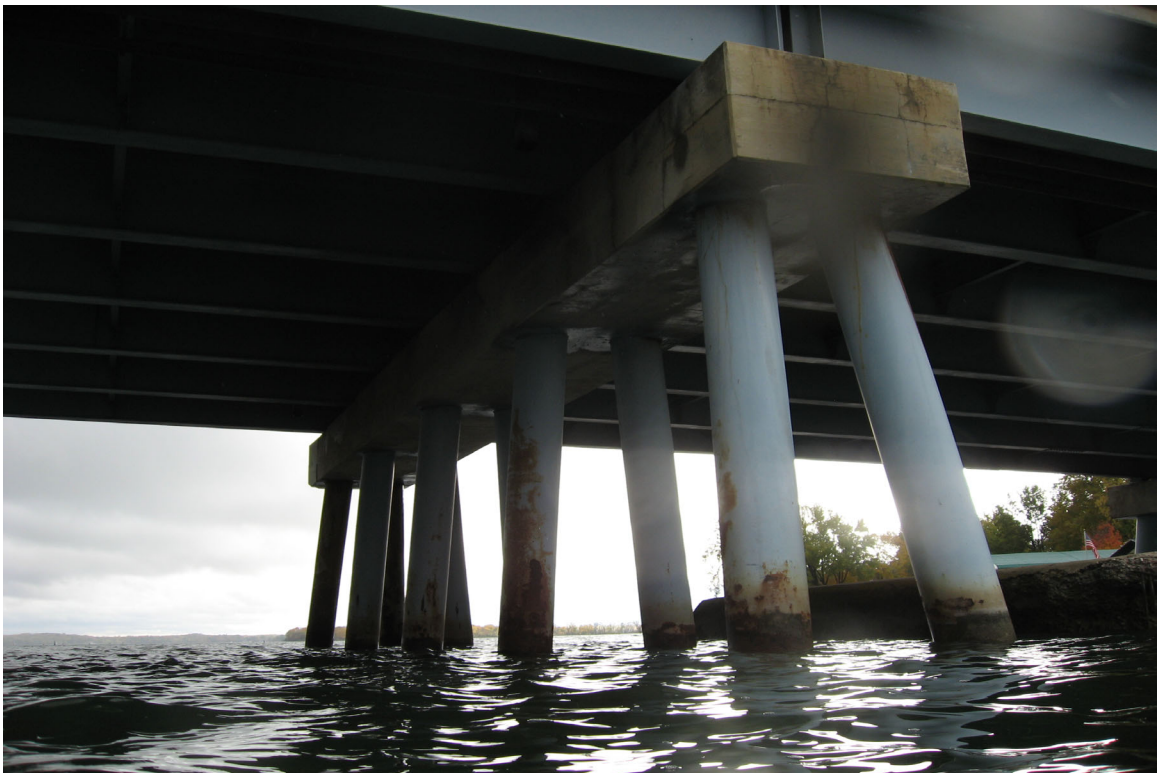
Photograph 6. View of Pier 6, Looking South.

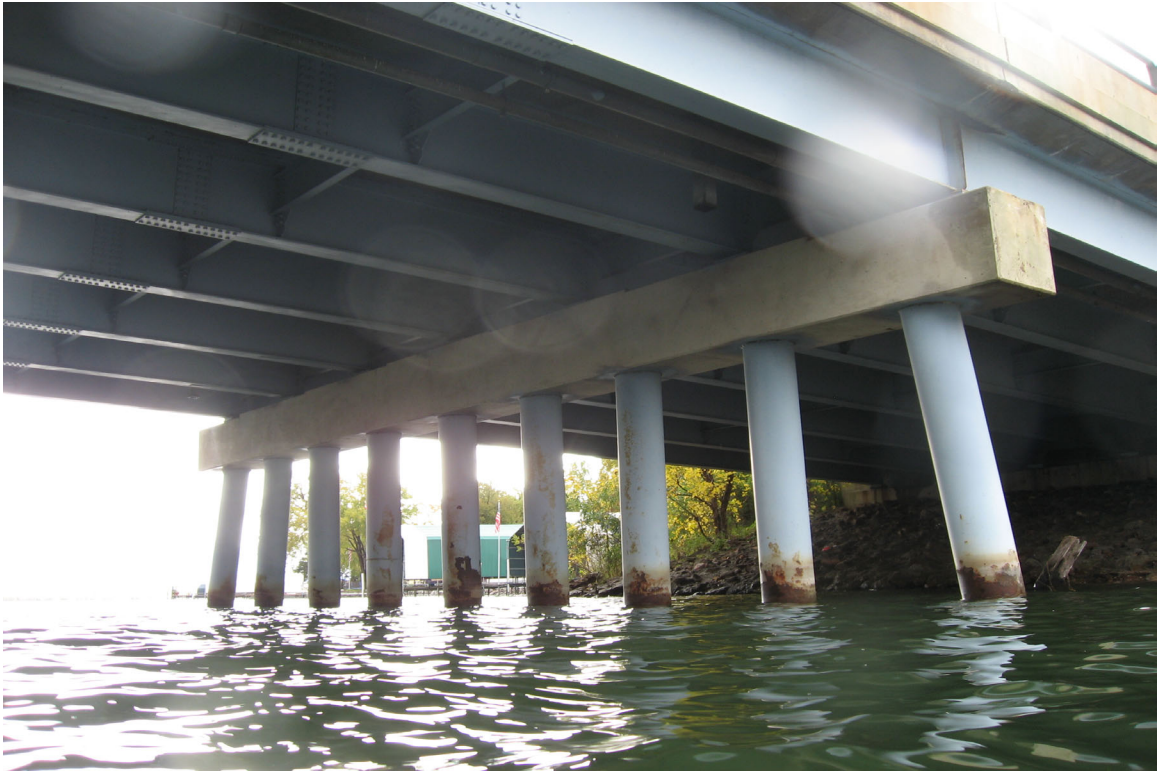
- (B) Several of the steel pipe piles exhibited minor dents probably due to impact and/or ice related damage above and below the waterline.
- (C) The concrete pile cap of Pier 7 exhibited areas of section loss approximately 1.5 feet long and 6 inches high on the west end with exposed reinforcing steel on the top and bottom edges.

Photograph 7. View of Pier 7, Looking South.

- (A) An above water inspection should address the pile cap end conditions at most piers.
- (B) Reinspect the submerged substructure units at the normal maximum recommended (NBIS) interval of five (5) years.

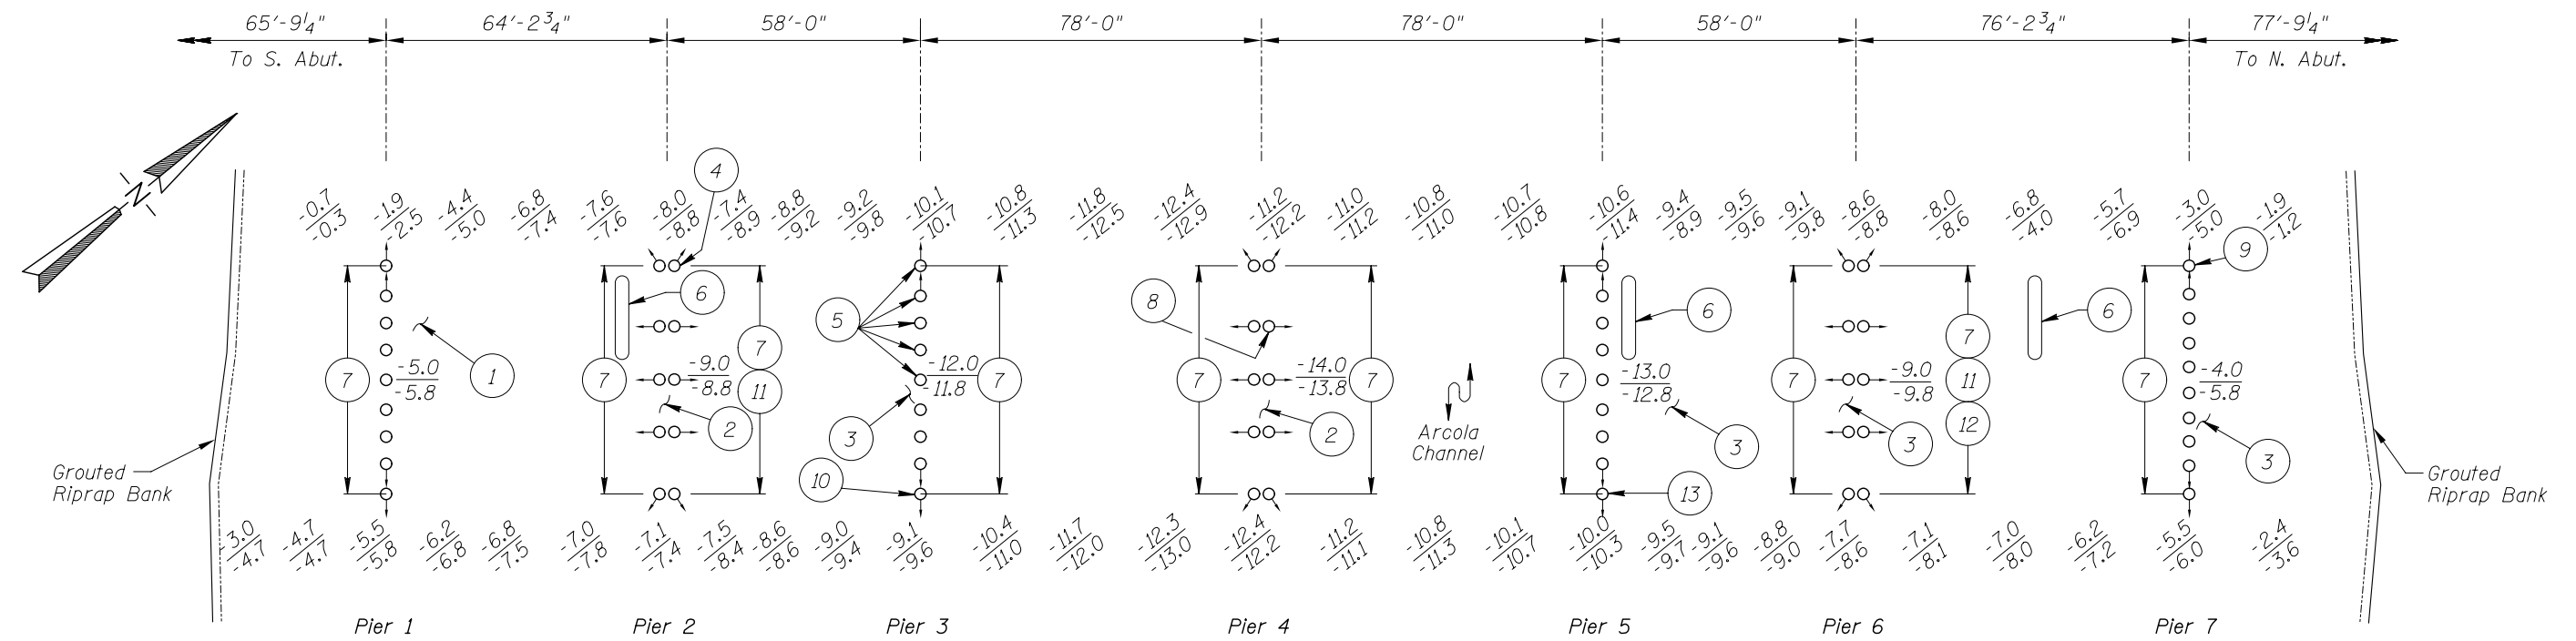
SOUNDING PLAN

- 1 The channel bottom around Pier 1 consisted of firm sand with 3 inches of maximum probe rod penetration.
- 2 The channel bottom around Piers 2 and 4 consisted of gravel, concrete rubble, and abandoned timber piles.

- 3 The channel bottom around Piers 3, 5, 6 and 7 and between the piers consisted of silty sand and scattered rocks up to 2 feet in diameter.
- 4 The steel pipe pile casing exhibited a dent that was 4 inches in diameter with 2 inches of penetration and was located 5 feet below the waterline on the northwest pile of Pier 2.

- 5 Five steel pipe pile casings at the west end of Pier 3 exhibited dents that were 12 inches long with 1 inch of penetration and were located 5 to 7 feet below the waterline.

- 6 Abandoned concrete piers were encountered near Piers 2, 5, and 7 and extended approximately 1 foot above the waterline.
- 7 The steel pipe pile casings typically exhibited light to moderate surface corrosion with minor pitting with rust scale delaminations up to 1/8 inch thick from 1 to 1.5 foot above to 1 foot below the waterline.

- 8 The steel pipe pile casing exhibited a dent 3 feet above the waterline that was 8 inches in diameter with 1/2 inch of penetration. A second 12 inch diameter dent was observed at 2 feet below the waterline, with 5 inches of penetration.

- 9 The concrete pile cap exhibited areas of section loss approximately 1.5 feet long and 6 inches high on the west end with exposed reinforcing steel on the top and bottom edges. 2 to 3 inch penetration and wide spread cracking with rust staining.

- 10 The concrete repair to the pile cap at the east end of Pier 3 exhibited a crack extending from the top to the bottom of the pile cap on the south face.
- 11 Minor cracking at Northwest end and heavy cracking at Southeast end of pier cap at Piers 6 and 2.
- 12 The piles exhibited lighter corrosion and/or coating failure from channel bottom to 6 feet above waterline.
- 13 The pier cap at Bent 5 has exposed reinforcing steel at Southeast end on the South side.
